# Failure Analysis of Economizer Tube Leakage Caused by Localized Internal Corrosion at Weld-Root Regions

Dede Rizka Ramadhan<sup>1,\*</sup>, Yudha Pratesa<sup>1</sup>, Johny Wahyuadi Mudaryoto<sup>1</sup>

**Keywords:** Economizer tube; Failure analysis; Localized internal corrosion; Weld-root; SEM-EDS

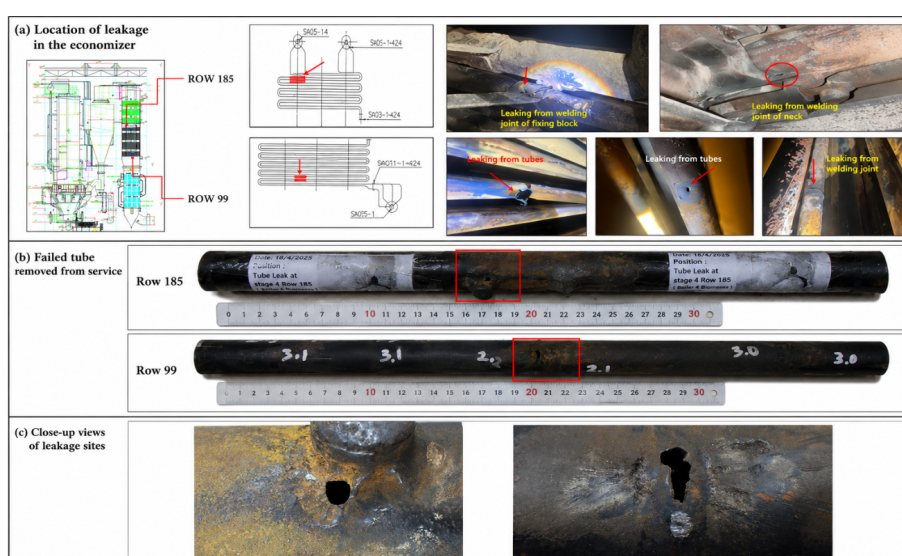
**Figure 1.** Field inspection and macroscopic appearance of failed economizer tubes.

Visual examination revealed that the damage was confined to limited regions adjacent to the circumferential weld and stopper-weld interfaces rather than being uniformly distributed along the tube surface. The external surfaces of the affected tubes remained relatively intact and showed no indication of severe overheating, creep deformation, fireside corrosion, or mechanical damage. In contrast, oxide deposits and corrosion products were concentrated around the leakage locations, particularly on surfaces exposed to the internal water–steam environment.

The morphology of the perforated regions provides evidence regarding the progression of corrosion attack. In both failed tubes, the cavity opening was noticeably larger on the internal diameter (ID) side than on the external diameter (OD) side, indicating that material loss originated from the tube interior and advanced progressively through the wall thickness. Such morphology is characteristic of internally initiated corrosion and is inconsistent with damage arising from external exposure.

- (a) Leakage locations identified in Rows 99 and 185 during boiler shutdown inspection.  
 (b) Failed tubes removed from service showing the position of leakage.

(c) Close-up views of perforated regions adjacent to welded joints. The damage was concentrated near the weld-root vicinity, whereas adjacent tube surfaces remained comparatively unaffected.

The field observations indicate that leakage originated from localized regions adjacent to the welded joints and progressed from the internal tube surface. However, visual inspection alone cannot determine whether the observed deterioration resulted from localized corrosion, material nonconformity, or changes in mechanical properties. Therefore, wall-thickness measurements, chemical composition analysis, and hardness testing were subsequently performed to quantify material loss, verify material conformity, and evaluate the integrity of the affected regions.

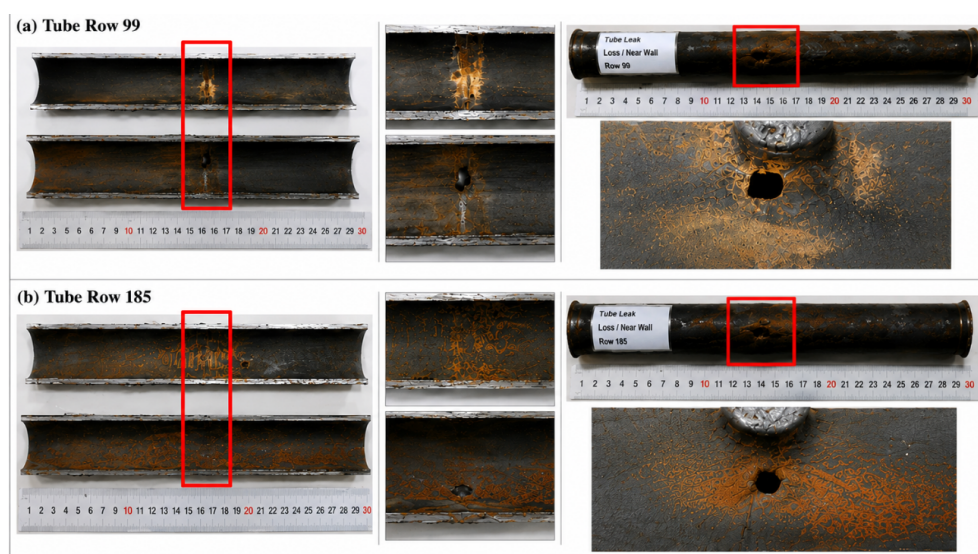
**Figure 2.** Wall thinning and perforation near welded regions.

Wall-thickness measurements revealed localized wall thinning in the vicinity of the leakage locations. The most severe reduction was identified in Tube Row 99, where the remaining wall thickness decreased from the nominal value of 3.00 mm to 1.85 mm. A similar pattern was observed in Tube Row 185, while adjacent regions retained considerably greater wall thickness. The uneven distribution of thickness loss indicates that material loss was concentrated near the welded regions rather than occurring uniformly across the tube surface. Representative wall-thinning features are shown in Figure 2, while the measurement results are summarized in Table 3.

- (a) Tube Row 99 showing localized wall thinning and through-wall perforation adjacent to the welded region.
- (b) Tube Row 185 exhibiting similar localized material loss and perforation near the weld penetration area. Damage was concentrated within confined regions, whereas surrounding tube sections remained comparatively unaffected.

The thickness measurements confirm that material loss was highly localized and concentrated near the leakage locations. The substantial difference between the failed regions and adjacent tube sections indicates that deterioration progressed within confined areas rather than through uniform wall reduction across the tube surface.

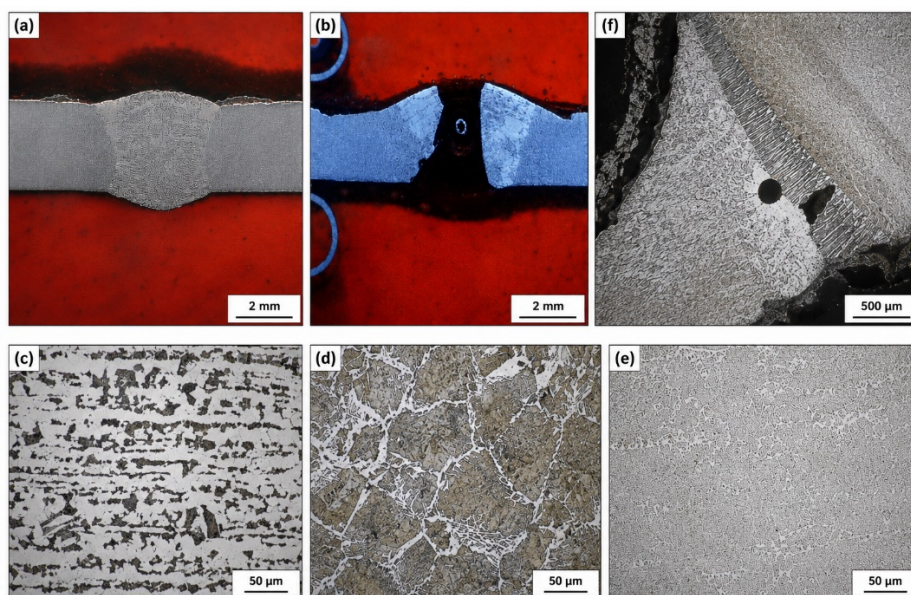
**Figure 3.** Metallographic comparison between reference and failed specimens.

Cross-sectional observations revealed a marked contrast between the reference and failed specimens. The reference weld exhibited a sound profile and a continuous internal surface without visible signs of deterioration. In the failed specimen, a through-wall opening was present adjacent to the weld root. As illustrated in Figure 4(a–b), the perforation was wider on the internal diameter (ID) side than on the external diameter (OD) side, indicating that metal loss progressed outward from the tube interior. The geometry of the damaged area is characteristic of corrosion-driven wall reduction rather than mechanical rupture.

Representative microstructures from the base metal (BM), heat-affected zone (HAZ), and weld metal (WM) are shown in Figure 4(c–e). All examined regions displayed ferrite–pearlite structures typical of ASTM A210 Grade C carbon steel. No evidence of overheating, creep damage, abnormal phase transformation, or grain-boundary deterioration was observed. The microstructural features therefore remained consistent with those expected for the material under normal service conditions.

A different condition was observed at the damaged weld-root interface, shown in Figure 4(f). The affected area exhibited disruption of the oxide layer accompanied by corrosion penetration and significant wall reduction. Material removal was confined to a narrow zone adjacent to the weld root, whereas the surrounding microstructure remained largely intact. This observation agrees with the thickness measurements presented in Section 3.2 and confirms that degradation was concentrated within a restricted area of the tube wall.

- (a) Reference weld cross section from a non-leaked tube.
- (b) Failed weld cross section showing perforation adjacent to the weld-root interface.
- (c) Base metal (BM).
- (d) Heat-affected zone (HAZ).
- (e) Weld metal (WM).
- (f) Corrosion penetration and wall-thickness reduction at the weld-root interface.

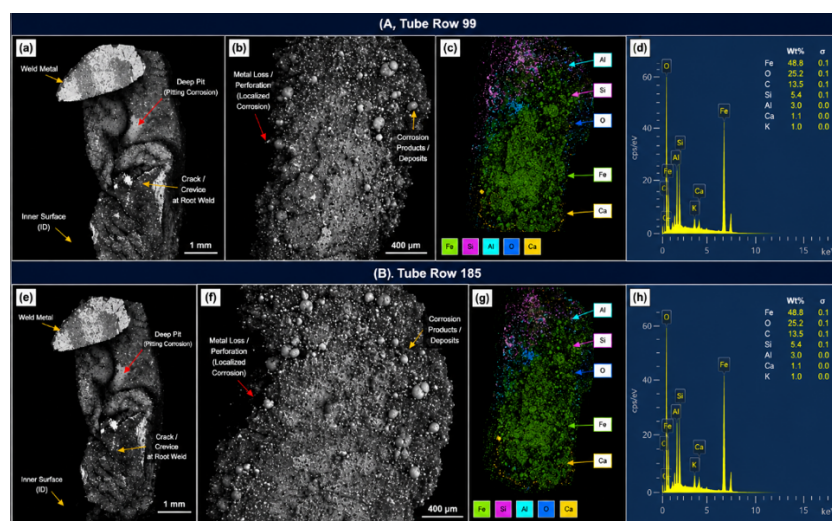
**Figure 4.** SEM-EDS characterization of leakage regions.

Further evidence was obtained from SEM examination. The corroded surfaces were characterized by irregular topography, shallow cavities, and discontinuities within the oxide layer. These features became increasingly pronounced closer to the perforated region, reflecting progressive deterioration of the protective surface film during service exposure. Representative SEM images and EDS results are presented in Figure 5.

The EDS spectra and elemental maps revealed that the corrosion deposits were composed primarily of iron and oxygen, confirming the presence of iron-oxide products. Sulfur-rich compounds were not detected in significant quantities. This compositional evidence is consistent with degradation occurring under the internal water-steam environment and does not support external fireside corrosion as the governing process.

Taken together, the metallographic and SEM-EDS findings establish a consistent sequence of damage development. Breakdown of the protective oxide layer was followed by corrosion penetration and progressive wall reduction within the same confined location. As the remaining wall thickness decreased, a through-wall opening eventually formed, providing a direct path for leakage.

- (a) SEM overview of the weld-root region,
- (b) higher-magnification image of the perforated area,
- (c) EDS elemental map of corrosion products, and
- (d) corresponding EDS spectrum.

- (e) SEM overview of the weld-root region,
- (f) higher-magnification image of the perforated area,
- (g) EDS elemental map of corrosion products, and
- (h) corresponding EDS spectrum.

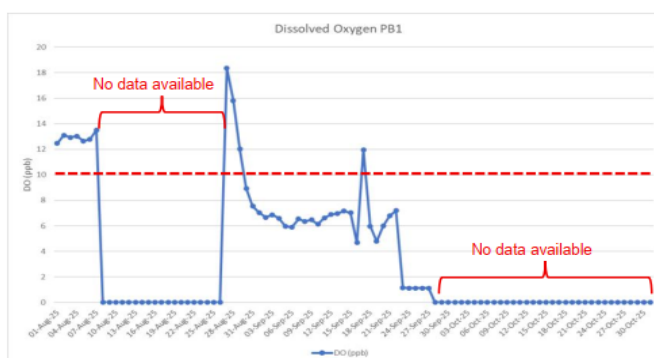
**Figure 5.** Record of Dissolved Oxygen (DO) at PB1

Although the available dissolved oxygen (DO) records were incomplete, the observed fluctuations, together with the metallographic and SEM-EDS findings, suggest that unstable oxygen conditions may have contributed to the corrosion process.

DO monitoring records from August to October 2025 are presented in Figure 5. The available measurements indicate dissolved oxygen (DO) concentrations ranging from approximately 1 to 19 ppb during the monitoring period. However, the records contain two intervals where no monitoring data were available, limiting the continuity of the dataset. Consequently, the available data are insufficient to establish a direct relationship between dissolved oxygen concentration and the observed corrosion behavior.

Although fluctuations in DO were observed in the available records, their influence on tube degradation cannot be conclusively determined because of the incomplete monitoring history. Nevertheless, the observed DO variations are consistent with the metallographic evidence of oxide-layer deterioration and the SEM–EDS identification of iron-oxide corrosion products. Therefore, dissolved oxygen fluctuations are interpreted as a possible contributing factor that may have influenced oxide-film stability, rather than as definitive evidence of the primary cause of economizer tube failure.

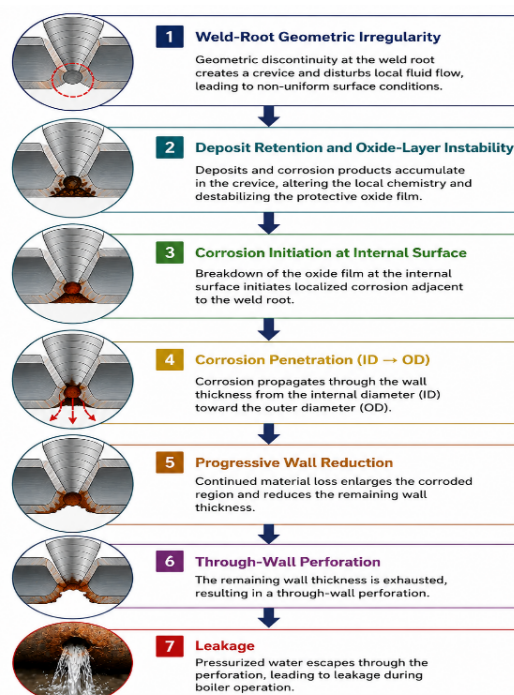
**Figure 6.** Sequential degradation mechanism of economizer tube failure associated with weld-root geometric irregularities.

The collective findings indicate a degradation sequence in which oxide-layer deterioration was followed by corrosion penetration and progressive wall reduction near the weld root. As material loss continued, the remaining wall thickness gradually decreased until a through-wall perforation was formed. Leakage occurred when the tube wall could no longer maintain pressure containment under normal operating conditions.

Geometric irregularities at the weld-root interface promoted deposit retention and disturbed local flow conditions, creating a favorable environment for oxide-layer instability. The resulting breakdown of the protective oxide layer initiated localized corrosion at the internal tube surface. Corrosion subsequently propagated from the internal diameter (ID) toward the external diameter (OD), causing progressive wall thinning adjacent to the weld root. Continued material loss reduced the remaining wall thickness until through-wall perforation occurred, allowing pressurized water to escape and resulting in tube leakage during service operation.

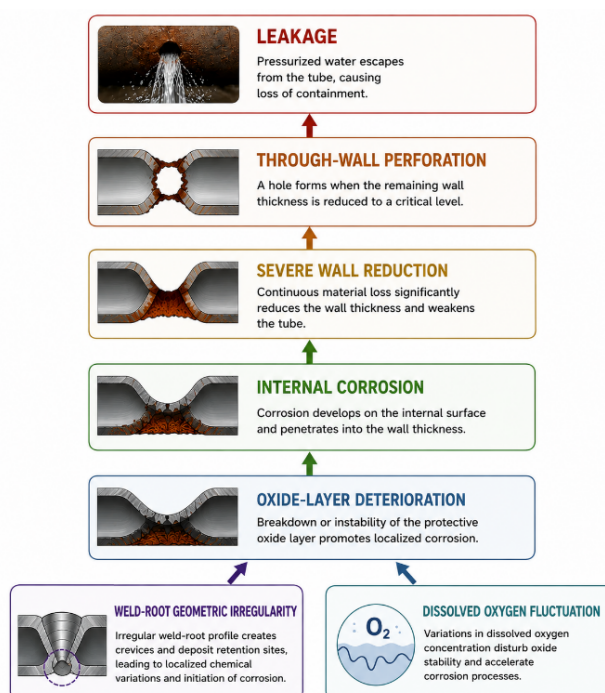
**Figure 7.** Root Cause Failure Analysis (RCFA) of economizer tube leakage.

Figure 7. Root Cause Failure Analysis (RCFA) of economizer tube leakage. Leakage resulted from through-wall perforation caused by severe wall reduction. The wall reduction developed through internal corrosion associated with oxide-layer deterioration. The underlying contributing factors were weld-root geometric irregularities and fluctuations in dissolved oxygen concentration, which promoted sustained corrosion activity near the internal tube surface.
